Crash Rating Report

*How safe
is your car?*

ncap
new car
assessment
program

Issue No. 1 • April 1993

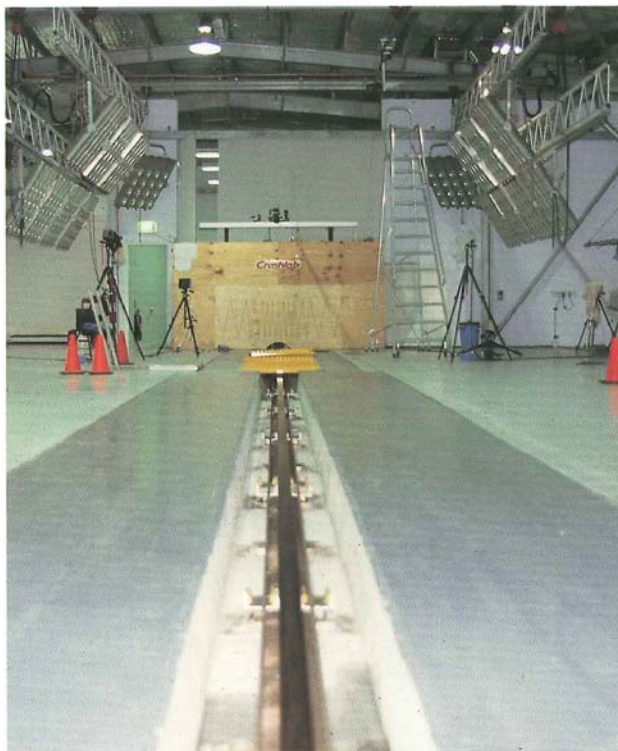
NCAP's test facility for the head-on collision crash test

In NCAP, nine different car models were crashed into a solid concrete wall at a speed of 56.3km/h (35mph).

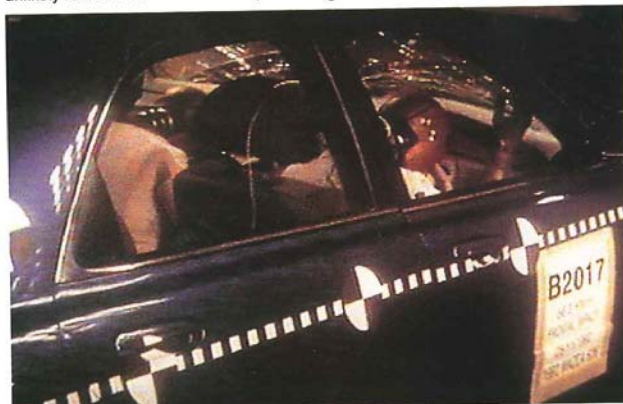
HIC readings indicated brain injury was possible for the driver and passenger.

The Mazda driver dummy's face struck the steering wheel then hit the top of the steering column. The driver recorded a mid-range Head Injury Criteria (1160) indicating that brain injury was possible.

The passenger dummy's head struck the dashboard during the crash, recording a mid-range HIC (930), indicating that brain injury was possible.

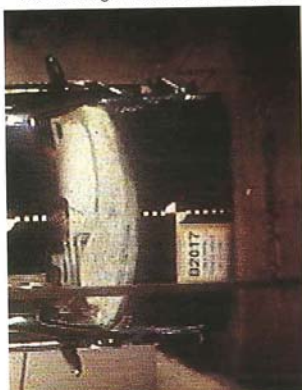
The Mazda was crushed an average of 682mm.

The Mazda's windscreen was cracked but remained in place and in one piece. The front of the car was crushed an average of 682mm.

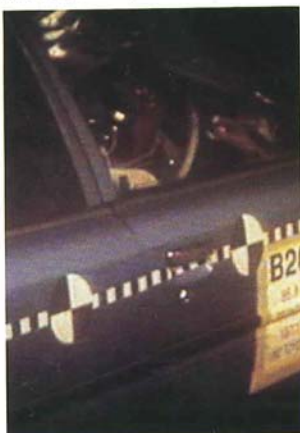
Brain injury was possible for both the driver and the passenger.

The Camry driver dummy's forehead struck the top of the rim of the steering wheel, then hit the steering wheel hub. The medium-range Head Injury Criteria (1090) indicated that brain injury was possible.

The passenger dummy recorded a medium-range HIC reading (1240) after its forehead hit the dashboard during the crash. This result indicated that brain injury was possible.

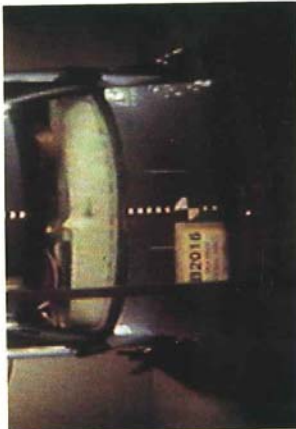
Most of the damage was confined to the front panels and bonnet.

The Camry's windscreen was cracked but remained in one piece and in place. Frontal crushing reduced the vehicle's length by an average of 568mm. Most of the damage was confined to the front panels and bonnet.

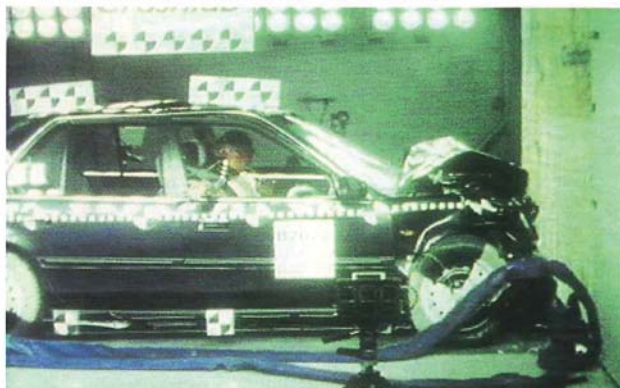
There was only minimal damage to the front doors and rear panels of the Honda.

but intact and in position. The front portion of the car was crushed an average of 598mm but there was only minimal damage to the front doors and rear panels.

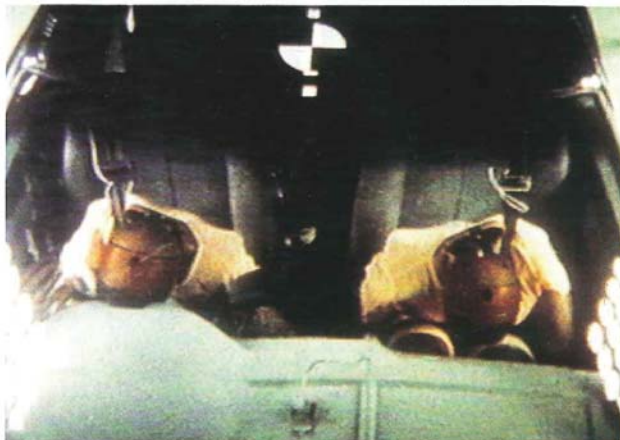
HIC readings indicated that brain injury was likely for both the driver and passenger.

Both the driver and passenger recorded high Head Injury Criteria ratings, indicating likely brain injuries. The driver's HIC rating was 1500 while the passenger rated 1330.

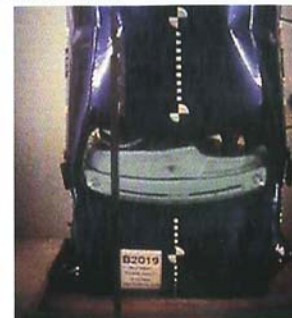
The Falcon was crushed an average 577mm and the roof severely buckled.

The windscreen of the Falcon had minor cracking around the base but remained in one piece and in place. The vehicle sustained damage to the front section with an average crush of 577mm. The roof of the Falcon was severely buckled with the middle pillars being bent inwards. Both rear wheels were also slightly toed-in and cambered.

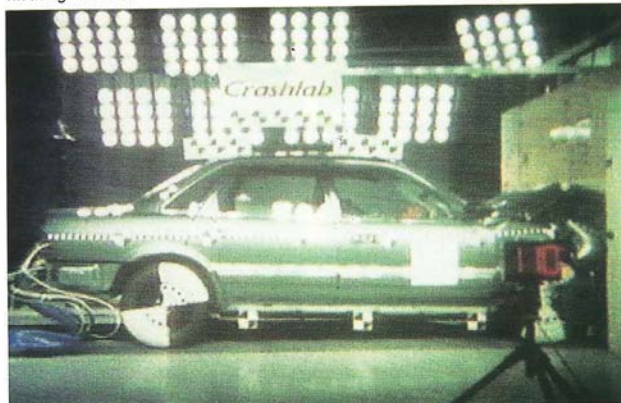
Almost all panel damage was restricted to the front of the Magna.

The lower edge of the Magna's windscreen cracked but remained intact and in place. Almost all panel damage was restricted to the front of the Magna with an average crush measurement of 644mm. The roof was slightly buckled at the right hand middle pillar.

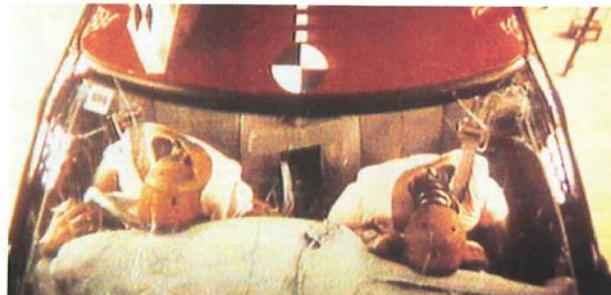
The HIC readings indicated that brain injury was likely for both the driver and passenger.

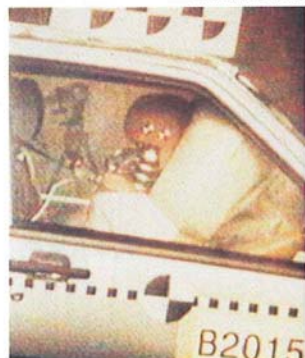
The Volvo's air bag prevented serious injury to the driver.
