# BMW X1 F48

SUV

from 10/2015

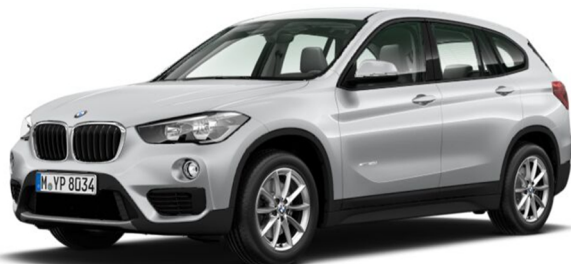
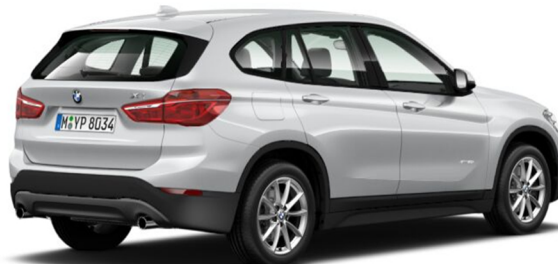
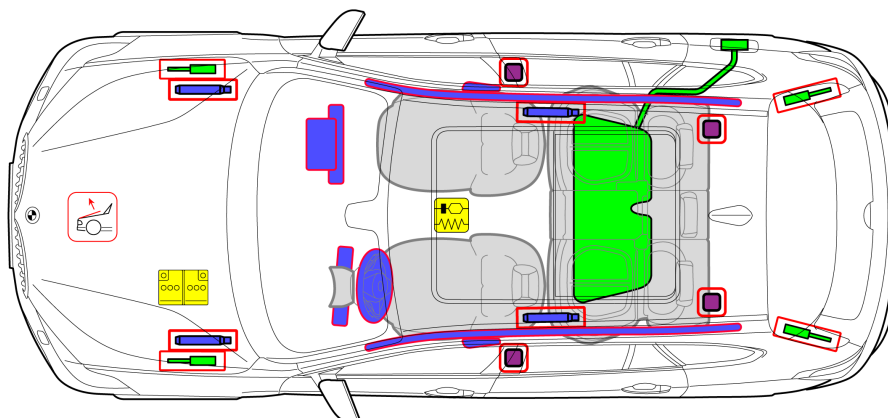
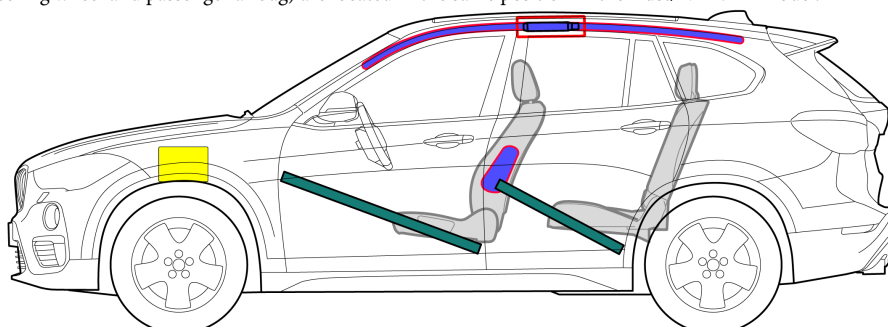
Note: The Rescue Sheet depicts a LHD vehicle (as allowed under the ISO 17840-1). All components (other than steering wheel and passenger airbag) are located in the same position in the Aust/NZ RHD model.

This overview shows the maximum range of equipment of the vehicle
